## **APPENDIX A RESPONSE TO AGENCY COMMENTS**

**Response to Comments on the Draft [Final] Remedial Action Construction Summary Report, Parcel E-2 Phase II, Hunters Point Naval Shipyard, San Francisco, California, June 2020, DCN: APTM-2005-0013-0047**

*Comments by: Nina Bacey, California Department of Toxic Substances Control, comments dated March 5, 2020; follow-up on July 1, 2020.*

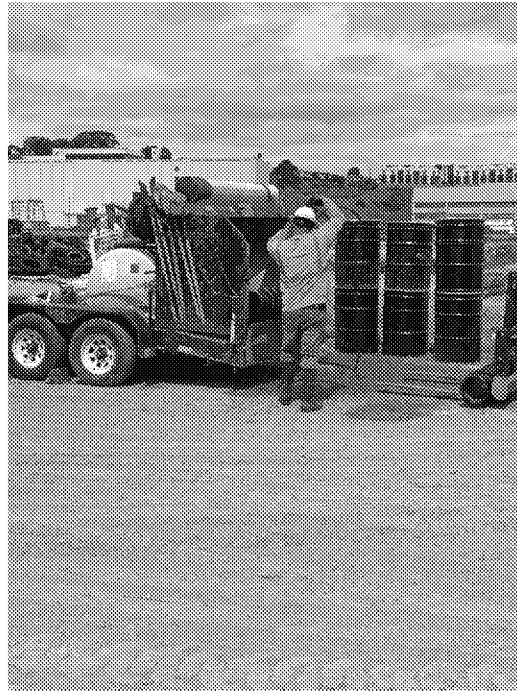
Steam Cleaning of Drilling Augers  
Installation of Monitoring and Extraction Wells and Piezometers

Cascade Drilling Performing Steam Cleaning of Drilling Augers during Installation of Upgradient Well Network Parcel E-2. April, 4 2019

--Photos taken during well installation showing on-site steam decontamination

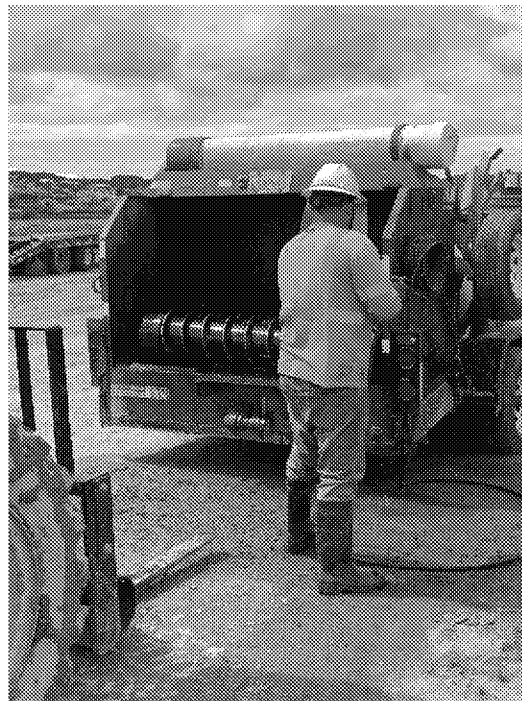
Cascade Drilling Performing Steam Cleaning of Drilling Augers during Installation of Upgradient Well Network Parcel E-2. April, 4 2019

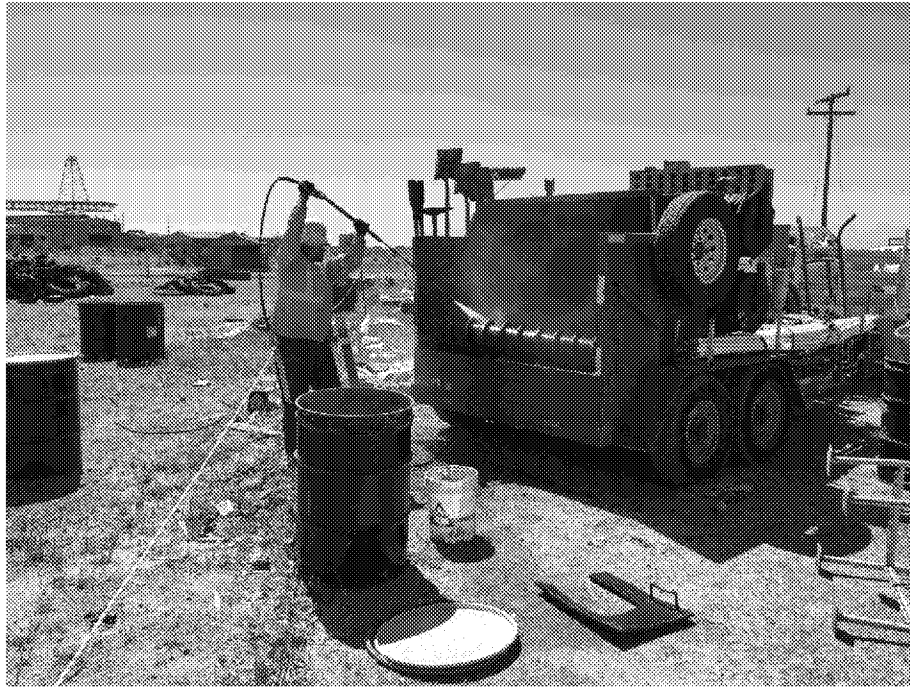
Steam Cleaning of Drilling Augers  
Installation of Monitoring and Extraction Wells and Piezometers

Cascade Drilling Performing Steam Cleaning of Drilling Augers during Installation of Upgradient Well Network Parcel E-2. June 2019

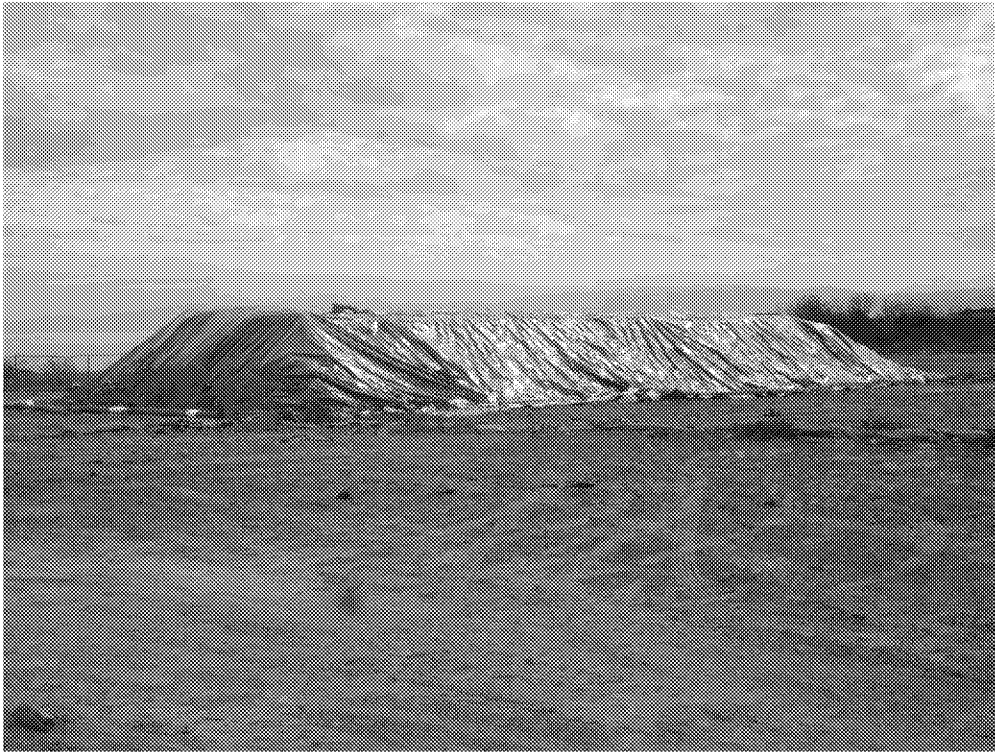
RCRA hazardous waste soil pile  
Staged within the AOC on a raised RSY pad

RCRA soil pile tarped with plastic sheeting and bermed with straw wattle wrapped in plastic to prevent infiltration from run-on. October, 1 2018

<p>19. The RCRA hazardous waste soil pile was not managed in accordance with federal and State of California regulations, potentially resulting in releases of hazardous waste or hazardous waste constituents into the environment. Investigation is needed to determine the nature and extent of any release of hazardous waste or hazardous waste constituents at the RCRA hazardous waste soil pile.</p>	<p>The lead soil piles were excavated, staged, and stored with the intent of utilizing the provisions afforded via the CERCLA/RCRA directive known as the Area of Contamination Policy (AOC) - U.S. EPA, EPA530-F-98-026. The excavation area and the waste staging area were contiguous and as such were part of the entire AOC footprint at HPNS. Under the AOC policy, excavation of soil is not considered a “point of generation” and consolidation of excavated soils is not considered removal from the land. Therefore, the HPNS remediation soils were not subject to the 90-day RCRA storage requirements during the time they were consolidated and were maintained until offsite treatment and disposal was conducted. While staged within the AOC, the lead soil pile was managed on a raised RSY pad which was underlain by a continuous layer of HDPE plastic and approximately 1-foot of compacted soil, all of which was also characterized and removed for off-site disposal at the completion of the project. While staged, the soil pile itself was tarped with plastic sheeting and bermed with straw wattle wrapped in plastic to prevent infiltration</p>

from run-on. [as evidenced by the attached photographic documentation; Appendix A] All soil stockpiles on site were regularly inspected as part of the required BMP inspections and any deficiencies were noted and repaired as soon as practical. This process was maintained until the remedial waste soils and debris were properly transported, treated, and disposed of at US Ecology located in Beatty, NV.  
The weekly BMP inspection logs are currently stored with the project files and are not typically included as part of the RACSR; however, they may be provided as a separate submittal.

--Project photo decontaminating management of the RCRA hazardous waste soil pile
